**PRELIMINARY ASSESSMENT/
VISUAL SITE INSPECTION**

**ACE BATTERY, INC.
INDIANAPOLIS, INDIANA
IND 016 389 546**

**FINAL REPORT
REVISION 2**

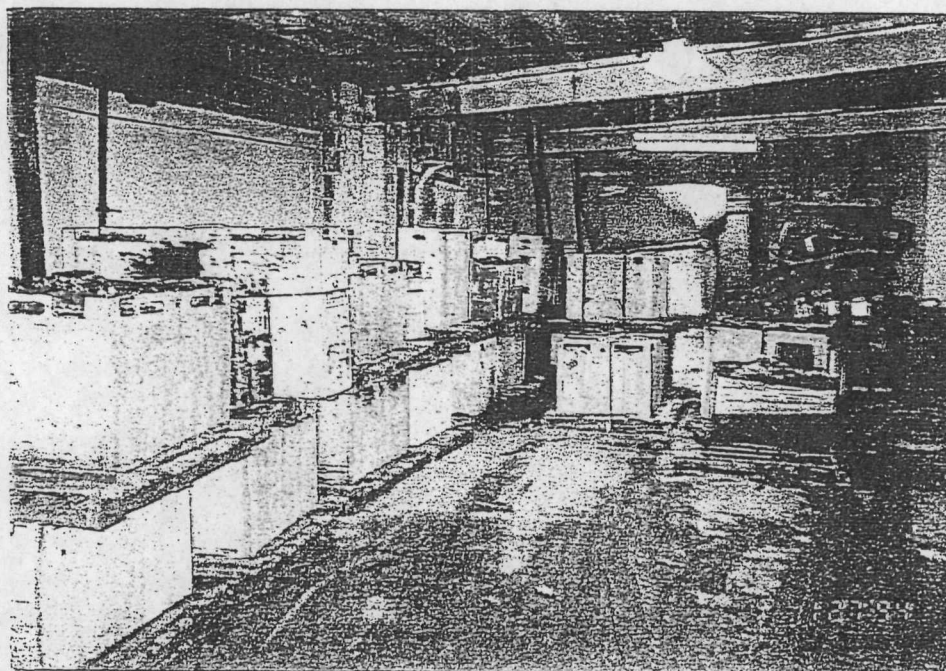
Photograph No. 2

Location: SWMU 1

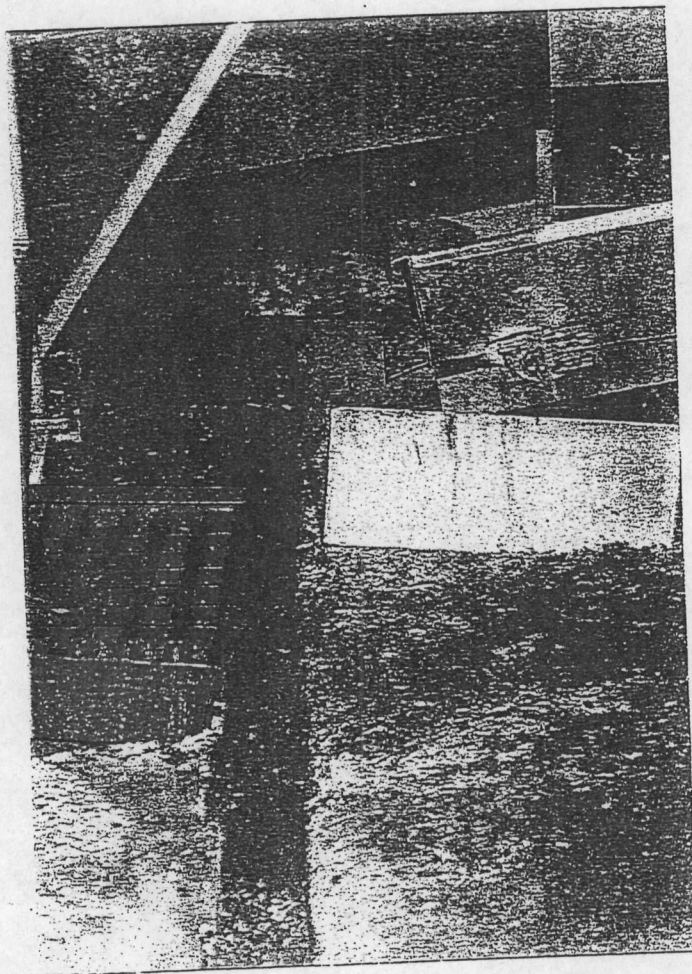
Photograph No. 6
Orientation: South
Description: Collection trough beneath saw assembly

Location: SWMU 4
Date: 01/27/94

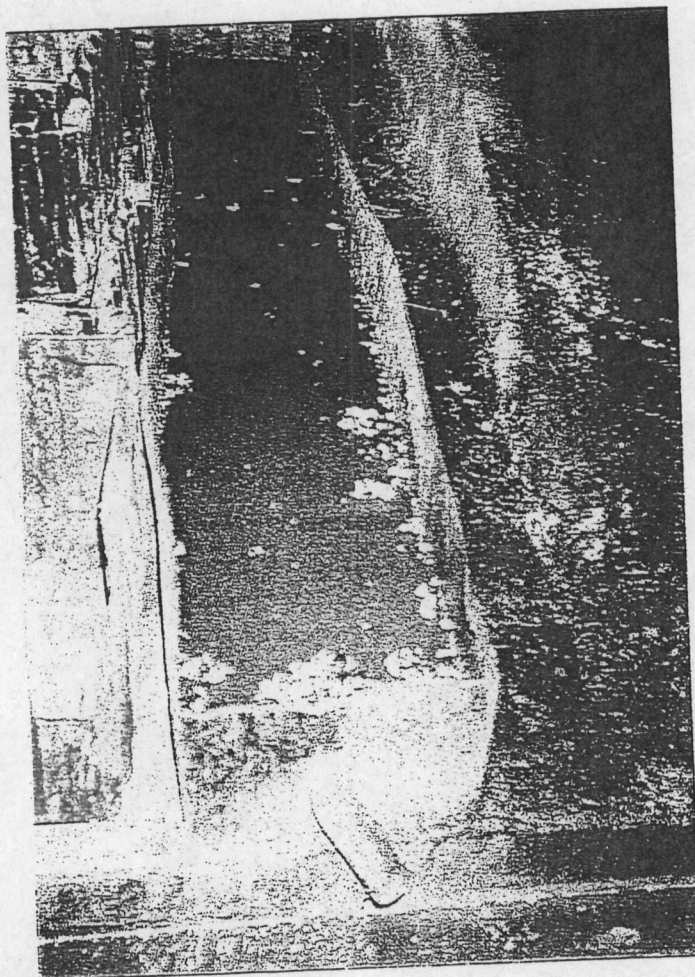
Photograph No. 7
Orientation: South
Description: Collection trough along west side of Tumbler

Location: SWMU 4
Date: 01/27/94
